Steering Upgrade

The steering tube is the Achilles' heel of a cable steering system but it's easy to protect.

Story and photos by Jerry Jones

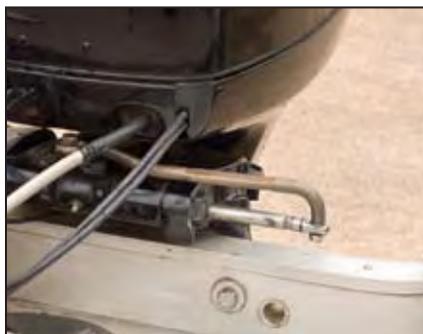
Typical factory configuration on a 90-hp Mercury.

A typical cable steering configuration has a shielded cable that connects the wheel at the helm to the tiller rod on the outboard. The aft end of the cable, called the steering rod, moves back and forth through the outboard

tilt tube as you steer. When you turn to the right, the steering rod extends from the port side of the tilt tube. While it's extended, it's exposed to splashing water and all kinds of contamination. Turn left and the steering rod pulls back inside the tilt tube, along with the moisture and contaminants it picked up while working outside the tilt tube. When drawn back into the tube, these elements go to work to corrode and the internal carbon steel parts. In extreme cases, moisture is drawn up the cable sheath by capillary action and the cable begins to rust. This may cause steering performance to become sluggish or fail completely.

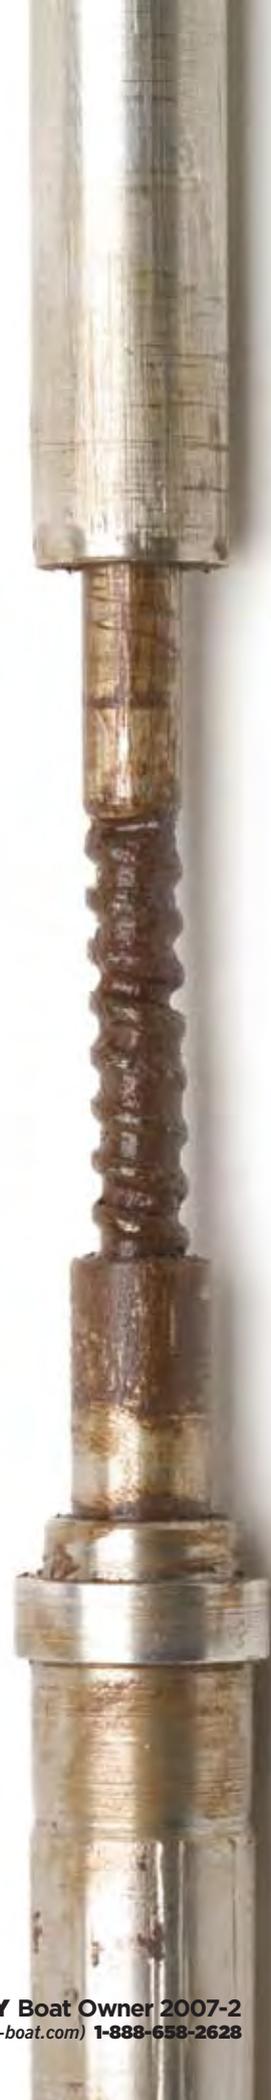
The Steersman Steering Guard replaces the factory nut on the port side of the outboard tilt tube. The steering rod, which is part of the cable assembly, passes through this nut as the boat is steered.

The Steersman Steering Guard, formerly known as the Widget, replaces the factory nut on the port side of the tilt tube. It includes a grease fitting and the all-important O-ring that wipes off the moisture and contaminants before they can get inside the tilt tube. Unlike the various "wipers" available, the O-ring causes the least amount of resistance to movement. The grease fitting allows for lubrication of steering parts. Very little grease is required but a bit of lubrication is very helpful any time you have the friction of a rod moving inside a pipe. Many boaters assume that the grease fitting found at the center of most tilt tube assemblies lubricates the steering; however, none of the grease from that fitting reaches steering parts. It only lubricates the tilt motion of the outboard.

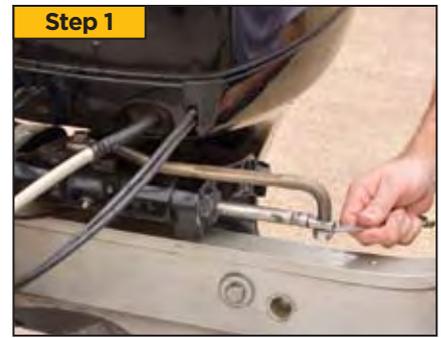
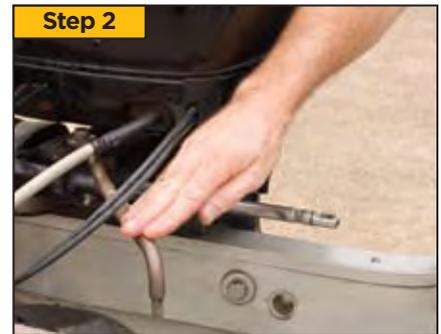
Step 1 Remove the locknut holding the tiller rod to the steering rod. Typically this 3/8-24 UNF nylon lock nut is removed with a 9/16" wrench.

Step 3 Remove the factory nut. This nut can be as large as 1-1/2" so have a large crescent or open-end wrench available. It's not necessary to remove the factory nut if at least three threads are already exposed. The Steersman can be threaded onto

Step 2 Lift the tiller rod and pivot it out of the way. If your steering has been stiff, this is a good time to diagnose the problem. If the steering is still stiff with the cable disconnected, the cable may need replacing. If it's smoother when disconnected, get out your engine manual and lubricate your engine pivot. A stiff pivot puts more pressure on the cable and hastens its demise.

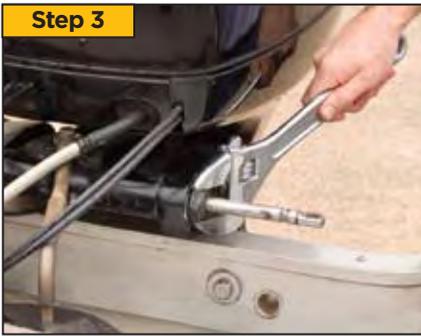
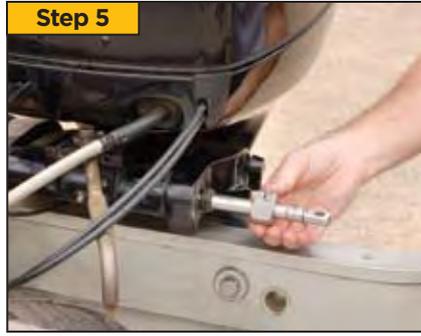
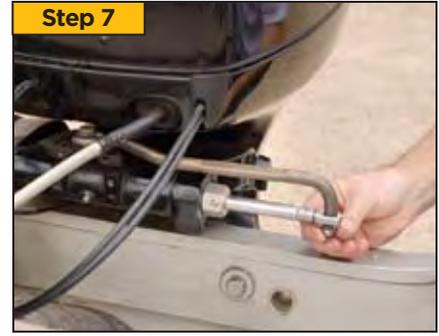
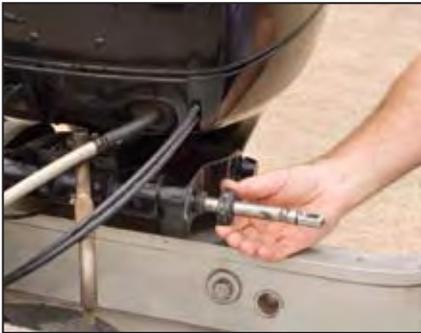
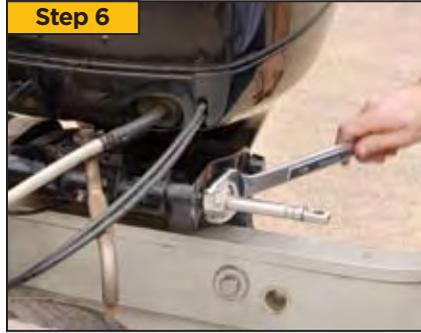
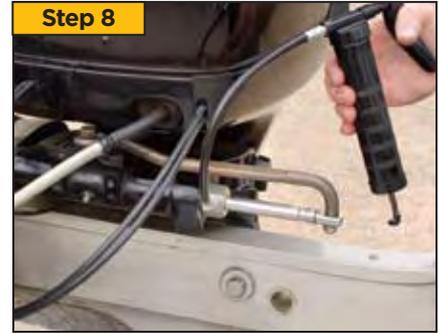
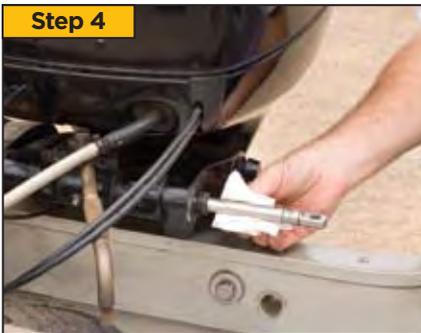
Step 4 Wipe the steering rod clean. You may see a bushing or wiper in the end of the threaded tilt tube. Remove it if possible. If there is any

wrench, tighten to a torque of 7 to 8 ft lb and then loosen the locknut 1/8 turn.

Step 8 Grease using a hand pumped grease gun only containing a marine Moly EP or lithium-based grease. Do not over lubricate, as this can cause hydraulic lockup. One full shot, two maximum.

"wobble room" between the inside of this tube and the steering rod, you do not have to remove this bushing. If it is truly a wiper or O-ring, it will be necessary to remove it for the proper flow of grease.

Step 5 Apply a small amount of grease to the O-ring and slide on the Steersman.

Step 6 Tighten the Steersman securely. It may be necessary to tighten both steering/tilt tube nuts prior to tightening. Make sure the grease fitting is accessible.

Step 7 Replace the tiller rod linkage nut and washer(s). Do not over tighten. Since this is a locknut, just tighten it gently until snug. It needs to be free to pivot. If you have a torque
